# **Laparoscopic sacral mesh fixation for ventral rectopexy – clinical implications from a cadaver study**

Argeny S, Zaussinger M, Maurer-Gesek B, Weninger WJ, Maier A, Reissig L,  
Umek W, Veit-Rubin N, Stift A, Riss S

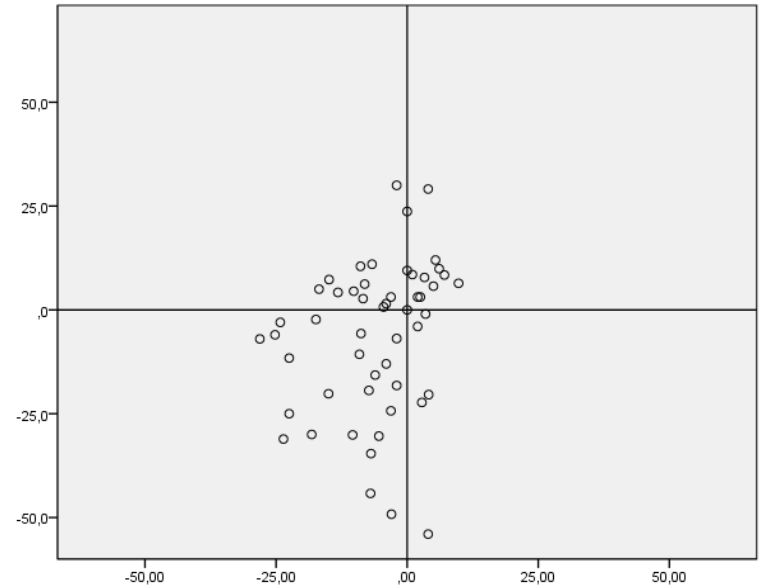
*MSP is found at 0/0.*

*Each circle represents a deployed tack.*

*Target area is the lower right quadrant representing the right surface of the S1 vertebra.*

- 52 tacks were laparoscopically deployed in 18 cadavers.
- Median distance to the midsacral promontory was 16.1 mm (0.0-54.2).
- Only 22 tacks (42.3%) were found on the right surface of the S1 vertebra, representing the respective targeted deployment area.

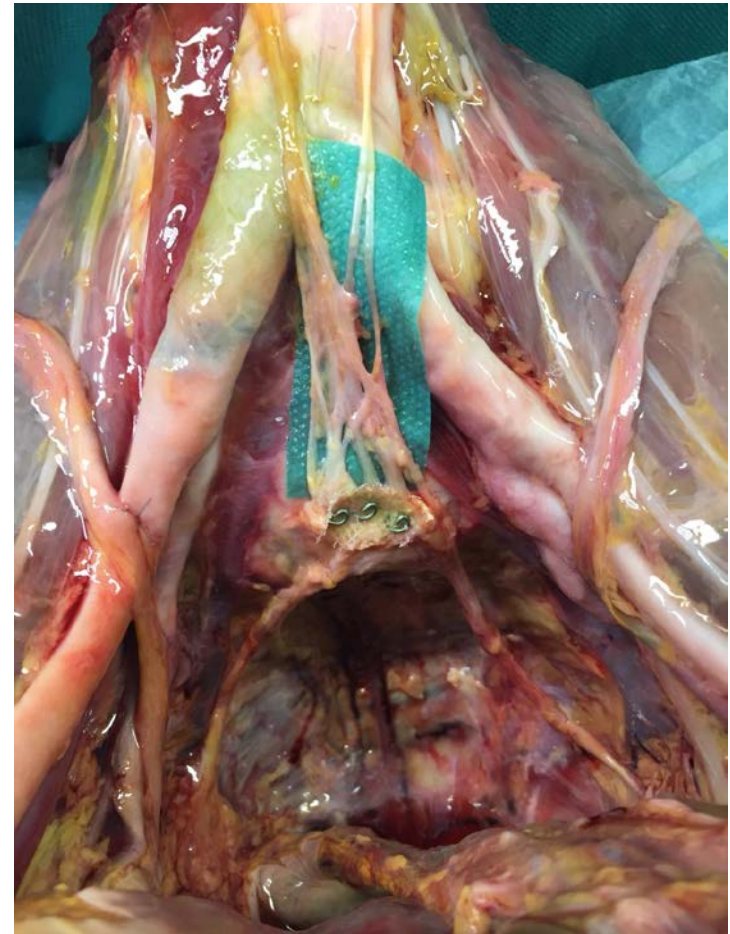
- In 14 cadavers, all tacks affected the hypogastric nerve plexus.
- Median distance to the major vessels was 10.5mm (0.0-35.0), and 32.1mm (7.5-46.1) to the right ureter.

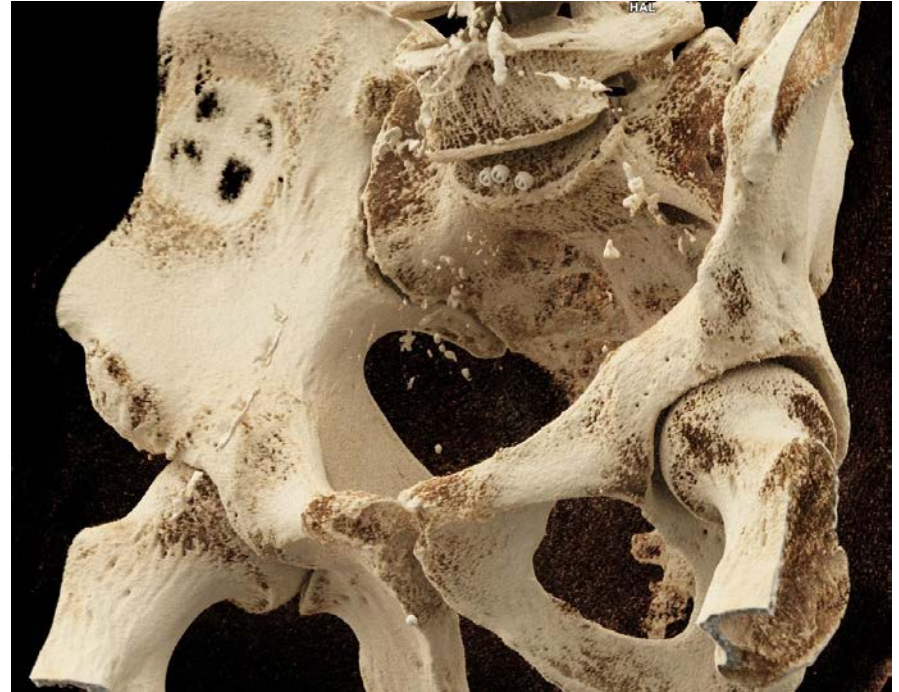
*Computed tomography reconstruction of a male pelvis.  
Frontolateral view with all tacks positioned on the L5 disc.*
